# REPORT OF FINDINGS

## ASBESTOS AND LEAD BASED PAINT ASSESSMENT

**McGill Ball Park  
56 South 4<sup>th</sup> Street  
McGill  
Nevada**

*October 15, 2012*

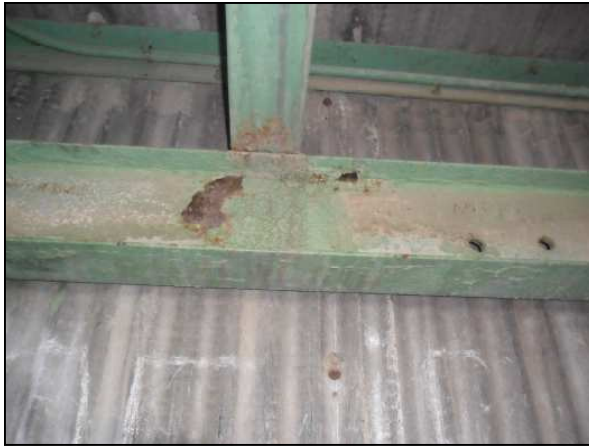
Picture 1 - Green Metal Beam Inside Grandstand.

Due to the poor condition of the lead based paint and its proximity to high traffic areas with children present, Macrotec recommends the reduction of potential hazards by abating or stabilizing all deteriorated lead based paint, in compliance with *EPA's 40 CFR Part 745 (Title X)*.

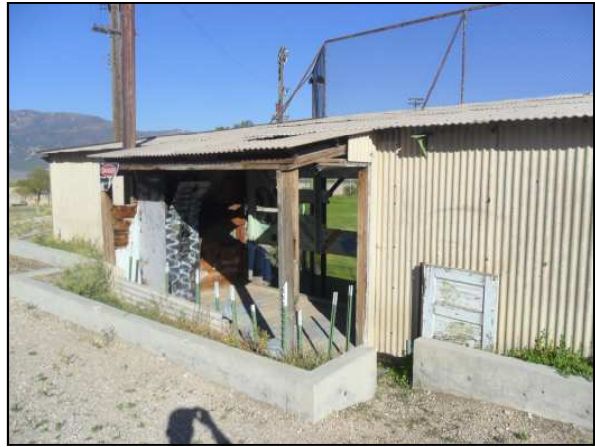
Picture 2 - Exterior Corrugated Transite Walls and Roof on the Grandstand.

Although the corrugated transite siding/roofing found to contain asbestos in this investigation is non-friable in fair condition, they need to be dealt with as RACM if they have a high probability of becoming pulverized or reduced to powder by the

forces expected to act on the material in the course of renovation. Macrotec recommends the removal of all ACM (in the manner described above) whenever feasible.

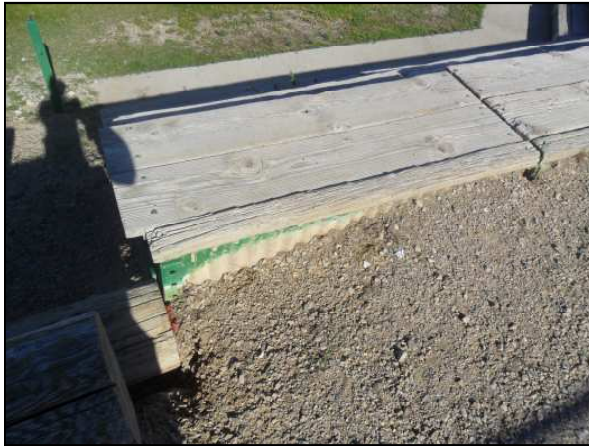
Picture 3 - Corrugated Transite Siding Behind the Outfield Bleachers. (From Above)

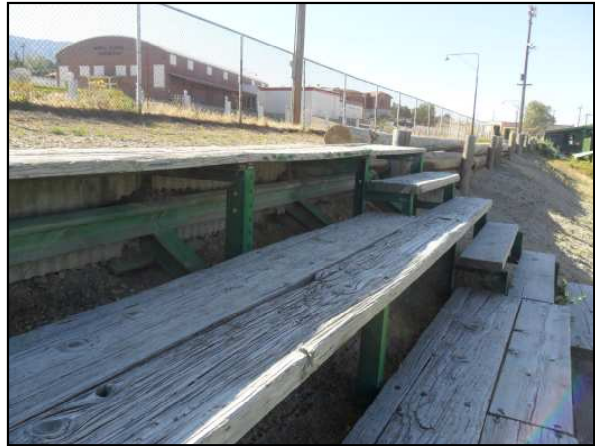
Picture 4 - Corrugated Transite Siding Behind the Outfield Bleachers. (From Below)

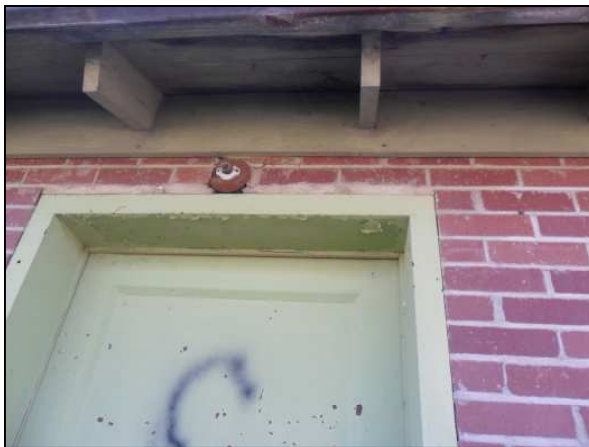
Picture 5 - Exterior Door, Doorframe, Fascia and Joists on the Restroom Building.

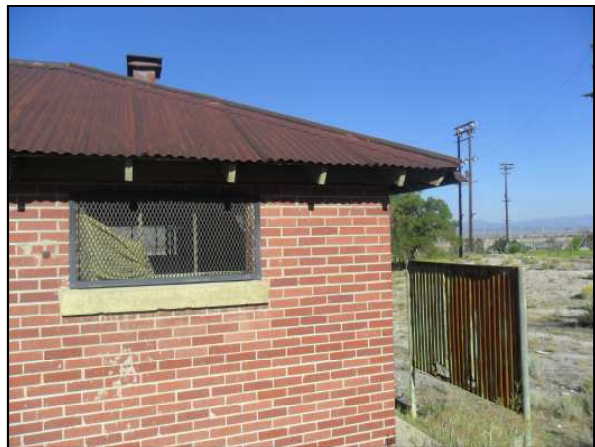
Picture 6 - Exterior Window Frame, Joists and Privacy Wall on the Restroom Building.
