Reno Office

815 Maestro Drive
Reno, Nevada 89511
Ph: 775.829.2245
Fax: 775.829.2213

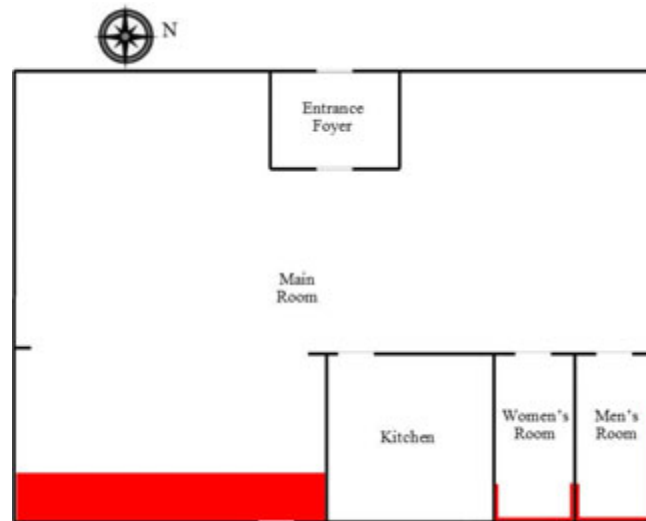
In the men's room and women's room, the water damage was on the walls, and adjacent floor. In the southeast portion of the main room, the water damage was on the walls, drop ceiling, hard ceiling (above drop ceiling) and the carpeted floor. The source of the water intrusion appeared to be from roofing leaks. An inspection of the roof found that the asphalt roll roofing was damaged in the areas above the restrooms and the southeast portion of the main room. Furthermore, the roof sloped from west to east, where a metal gutter ran along the east edge of the roof, inside of the building's outer brick wall. This gutter had a number of patches, where roofing mastic was used to evidently repair past leaks. Please see Appendix A for photographs of the areas described above.

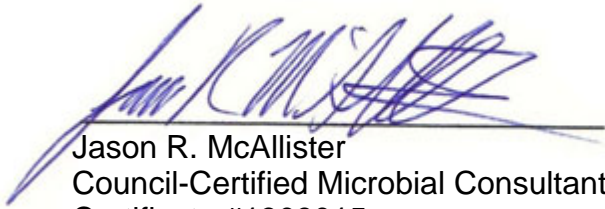
Jason R. McAllister
Council-Certified Microbial Consultant (CMC)
Certificate #1309015

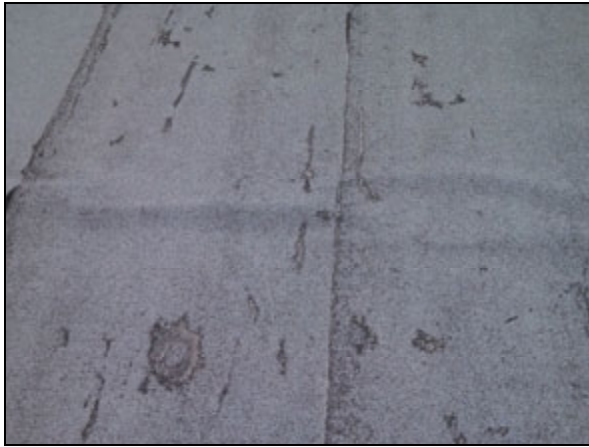
Picture 1—Heavily worn and bucking asphalt roll roofing above the southeast section of the main room.

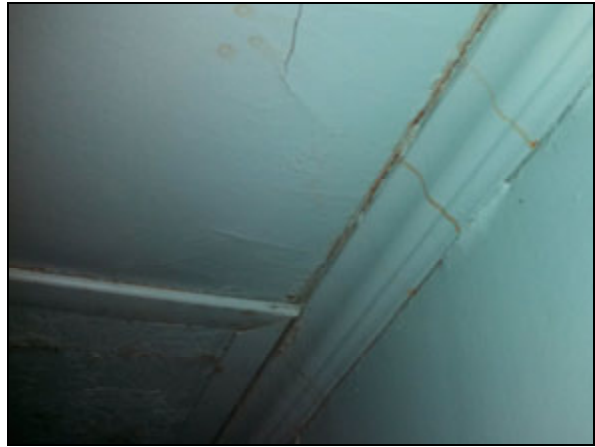
Picture 2—Water damaged wall, ceiling, and crown molding above the drop ceiling in the southeast section of the main room.

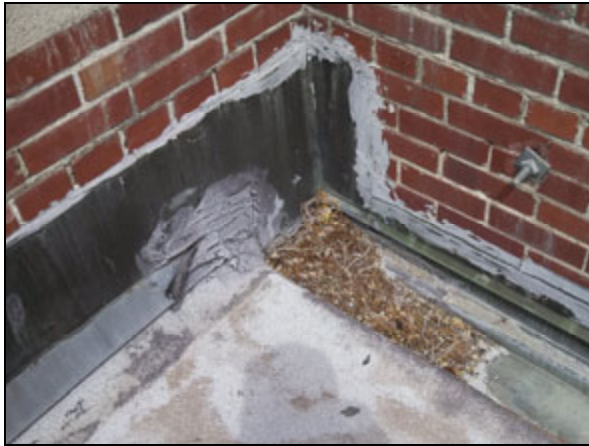
Picture 3—Old roof mastic used to seal seams on and adjacent the metal gutter. Note that the gutter is on the interior of the building's outer brick wall.

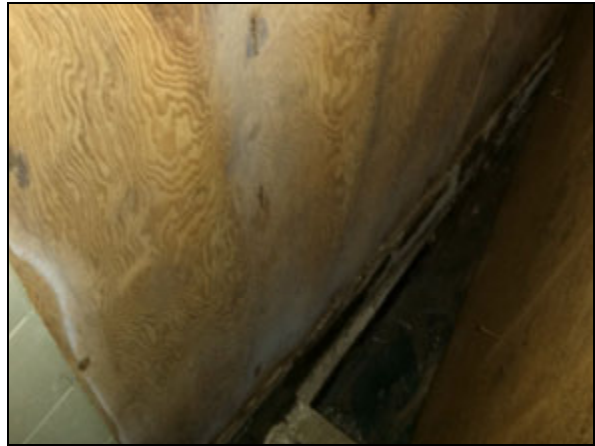
Picture 4—Water damaged plywood behind the paneling on the north wall in the men's room.

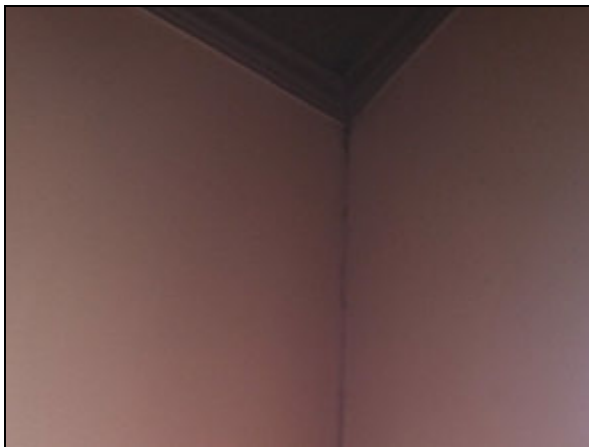
Picture 5—Water damage on the wallboard walls in the women's room.

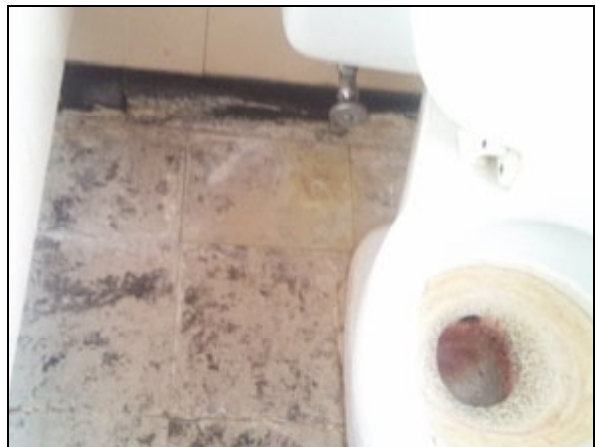
Picture 6—Water damaged wall, base cove and floor tile in the women's room. Note: There is also visible mold growth in the toilet.
