REPORT OF FINDINGS

ASBESTOS AND LEAD BASED PAINT ASSESSMENT

**Pahrnagat Middle/High School
Multi-Use Building
262 Weeping Willow Avenue
Alamo
Lincoln County
Nevada**

*October 16, 2012
Project No. 804.11.001 – Task T2L-HZW*

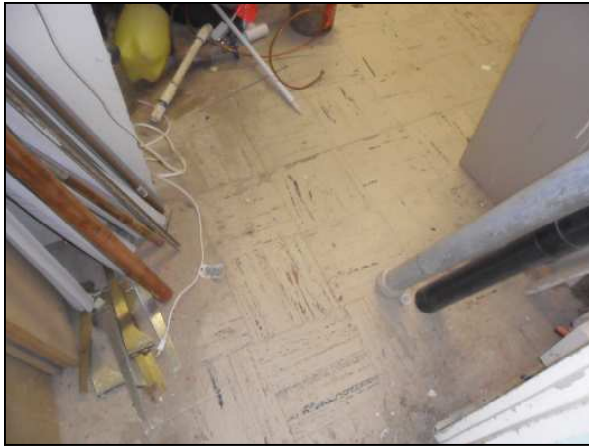
Picture 1 - 9"x9" Beige Floor Tile in the Maintenance Office.

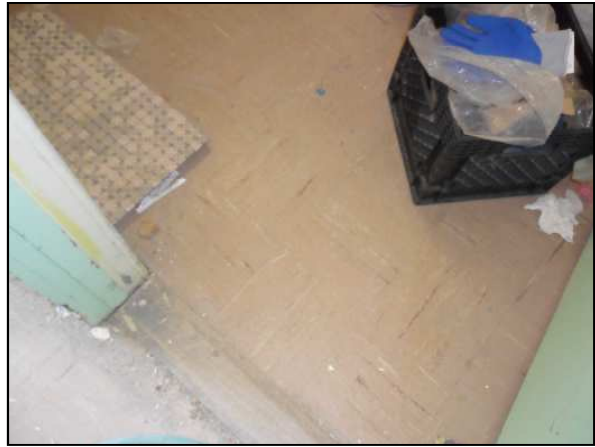
Picture 2 - 9"x9" Beige Floor Tile in the Maintenance Office.

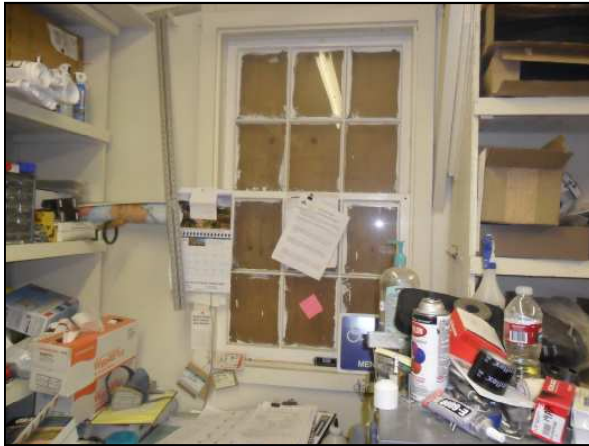
Picture 3 - Window Sash in the Maintenance Office.

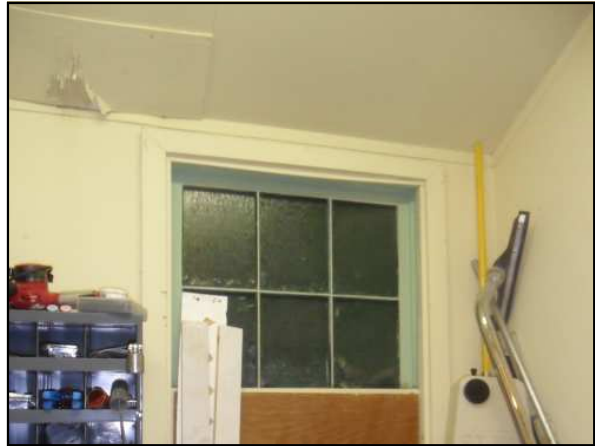
Picture 4 - Window Sash, Window Pane, Walls and Ceiling in the Parts Room.

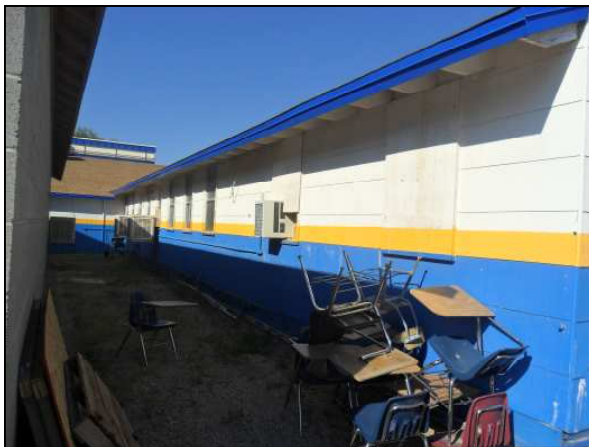
Picture 5 - Exterior Transite Walls, Window Frames, Window Sills, Soffits and Joists on the West Side of the Building.

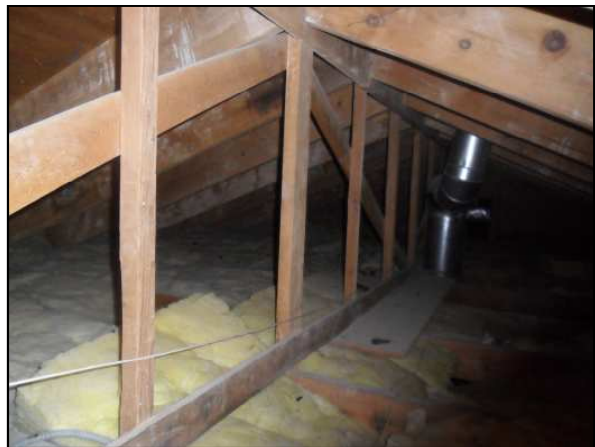
Picture 6 - View of Attic Space. No suspect ACM was observed.
