**PHASE I ENVIRONMENTAL SITE ASSESSMENT
40-ACRE PARCEL
AMARGOSA VALLEY, NEVADA 89020
NE ¼ NW ¼ T16S, 49E, SECTION 16
PARCEL NO. 19-131-02**

December 3, 2003
Project No. 301386001

Subject: Phase I Environmental Site Assessment
40-Acre Parcel
Amargosa Valley, Nevada 89020
NE1/4 NW1/4 T16S, R49E, Section 16

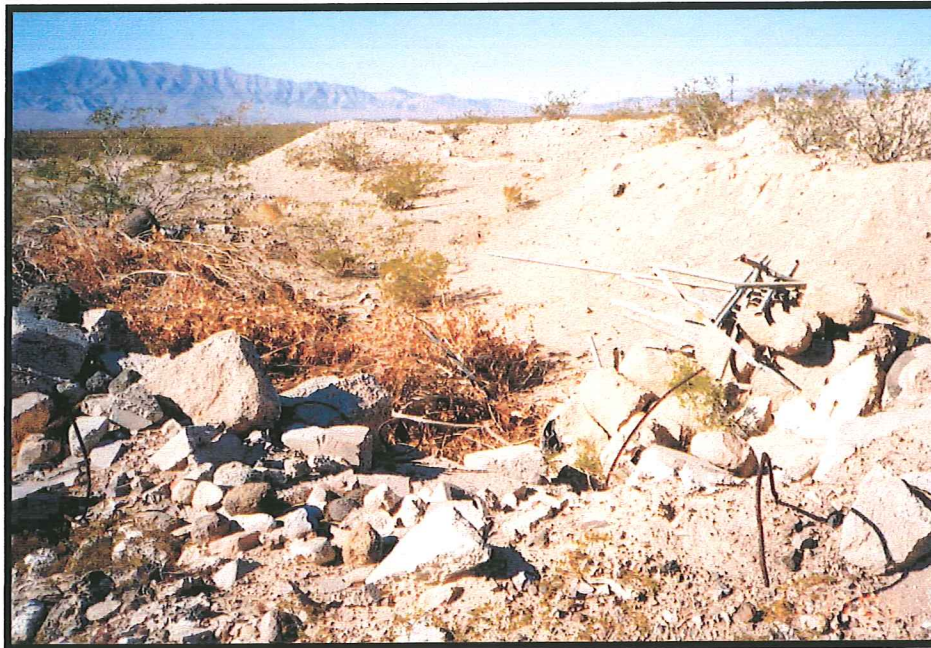
The subject property consists of a 40-acre vacant parcel. The site has not been developed and is covered with scattered natural vegetation. A small debris pile is located near the northwest corner of the property. The small debris pile consists of discarded concrete, metal fence posts, and landscape debris. A dirt road cuts through the subject property starting in the southwest corner and continuing in a northeast direction.

Photograph 7: View of debris pile located at the northwest portion of the property.

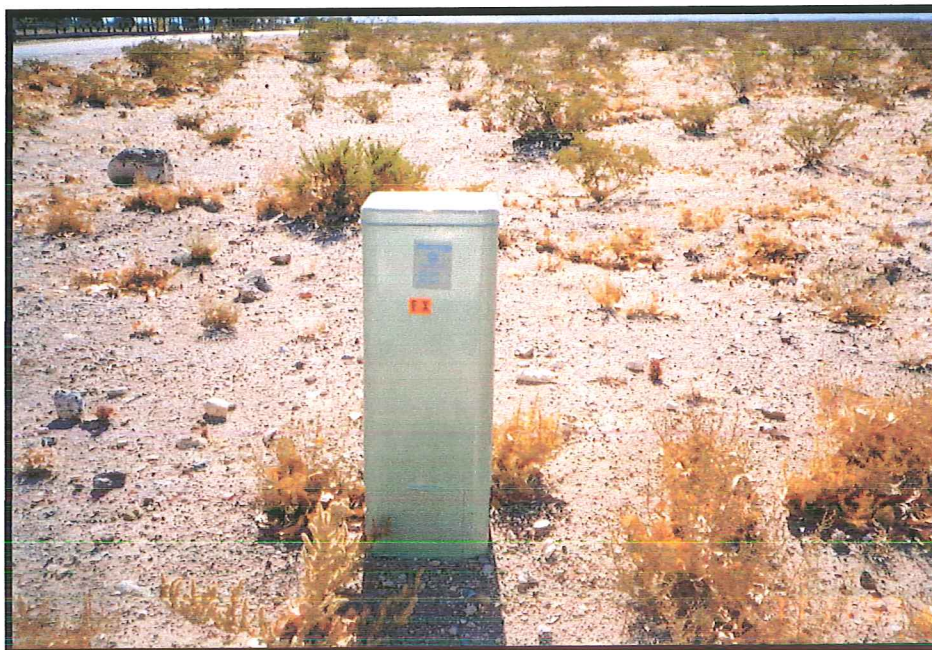
Photograph 8: View of the fiber optic box located at the northeast corner of the property.

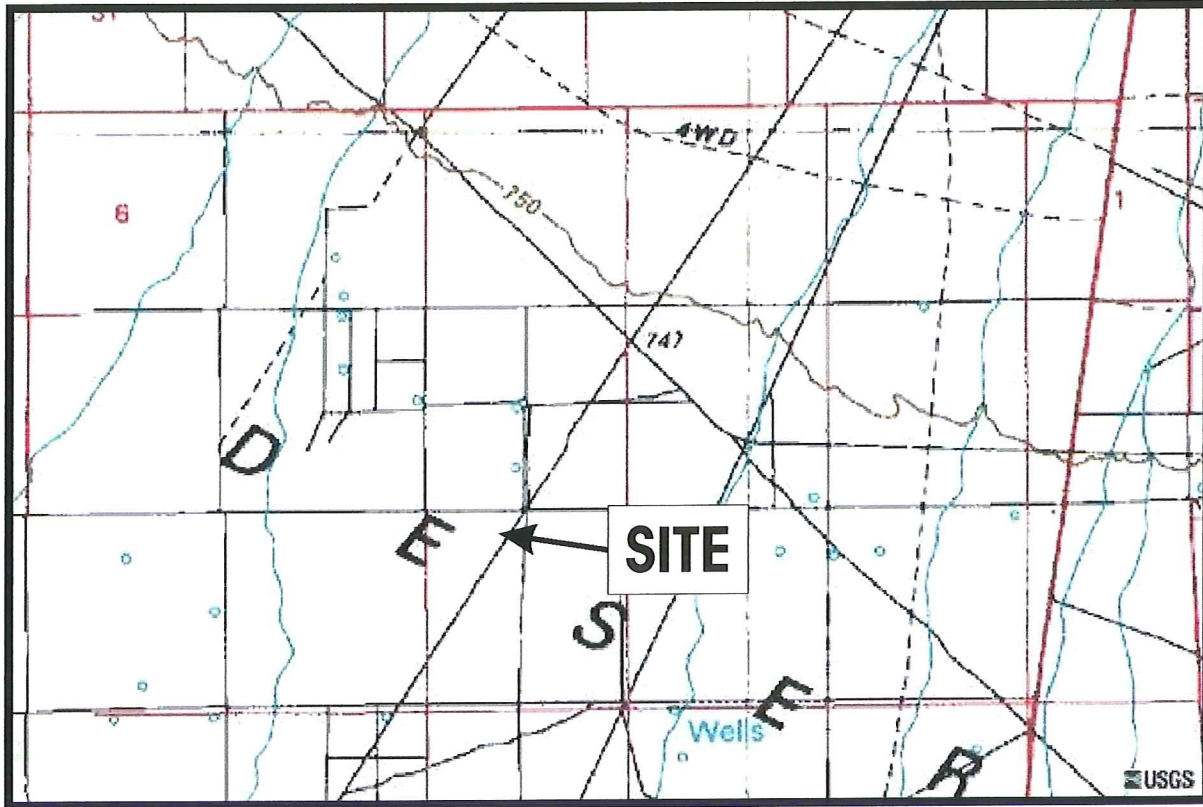
Historical Topographic Map

The USGS South of Amargosa Valley, Nevada, Provisional Edition, 7.5 minute quadrangle topographic map, dated 1984, shows the subject property to be at an elevation of approximately 2,420 feet above mean sea level with the drainage of the subject property trending to the southwest. A copy of the topographic map is included in Appendix C.

Source: USGS South of Amargosa Valley, Nev., Provisional Edition 1984
(Contour elevations in meters)
