**PHASE I ENVIRONMENTAL SITE ASSESSMENT
GABBS RECREATION HALL
531 AVENUE "E"
GABBS, NEVADA 89409**

Subject: Phase I Environmental Site Assessment
Gabbs Recreation Hall
531 Avenue "E"
Gabbs, Nevada 89409

**HAZARDOUS BUILDING MATERIALS SURVEY
GABBS RECREATION CENTER
531 AVENUE "E"
GABBS, NEVADA**

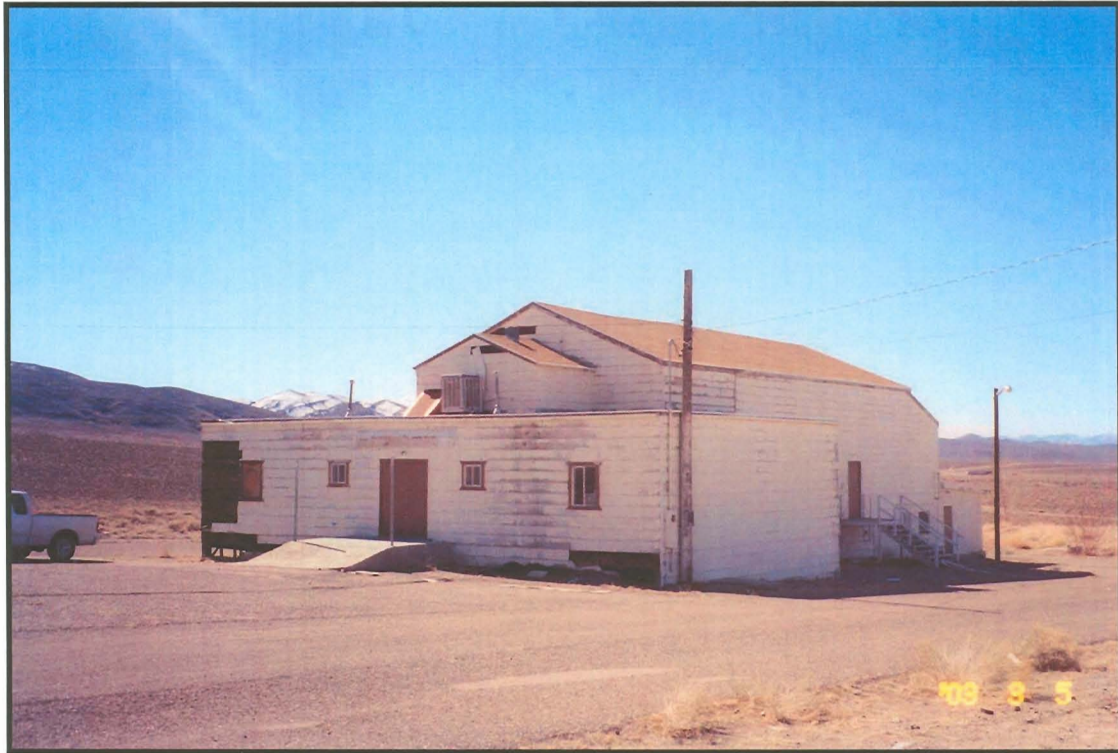
Photograph 1: Subject site, view facing south.

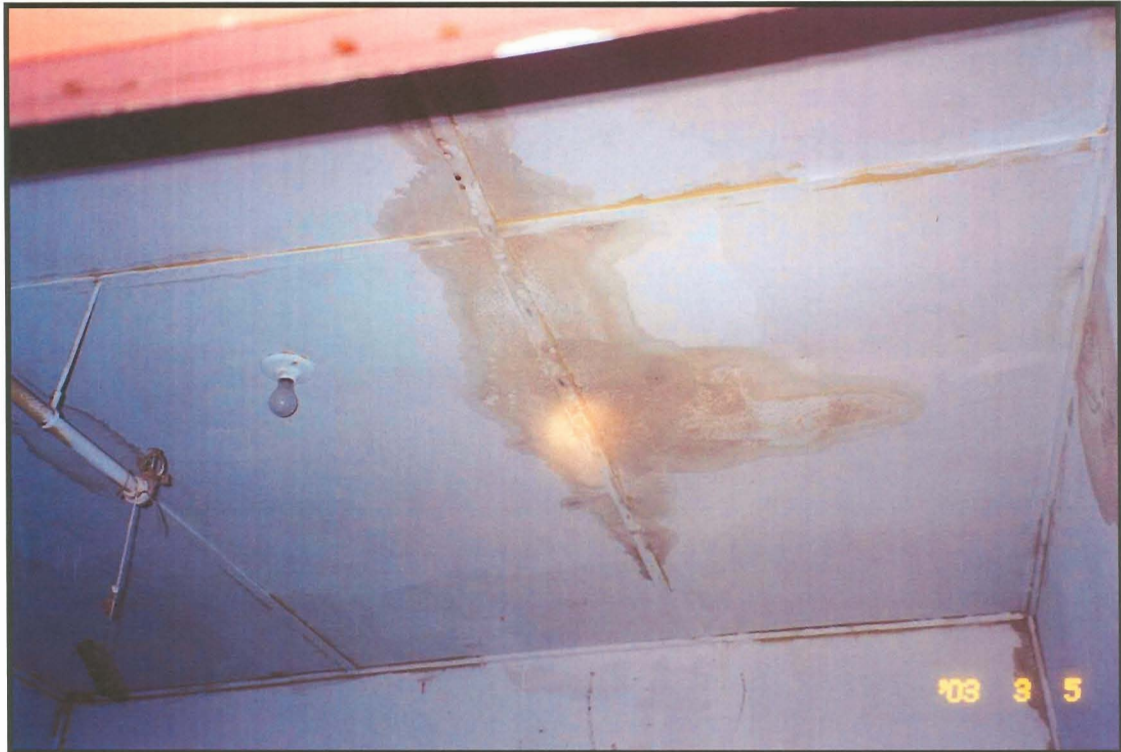
Photograph 3: View of water marks from leaking ceiling.

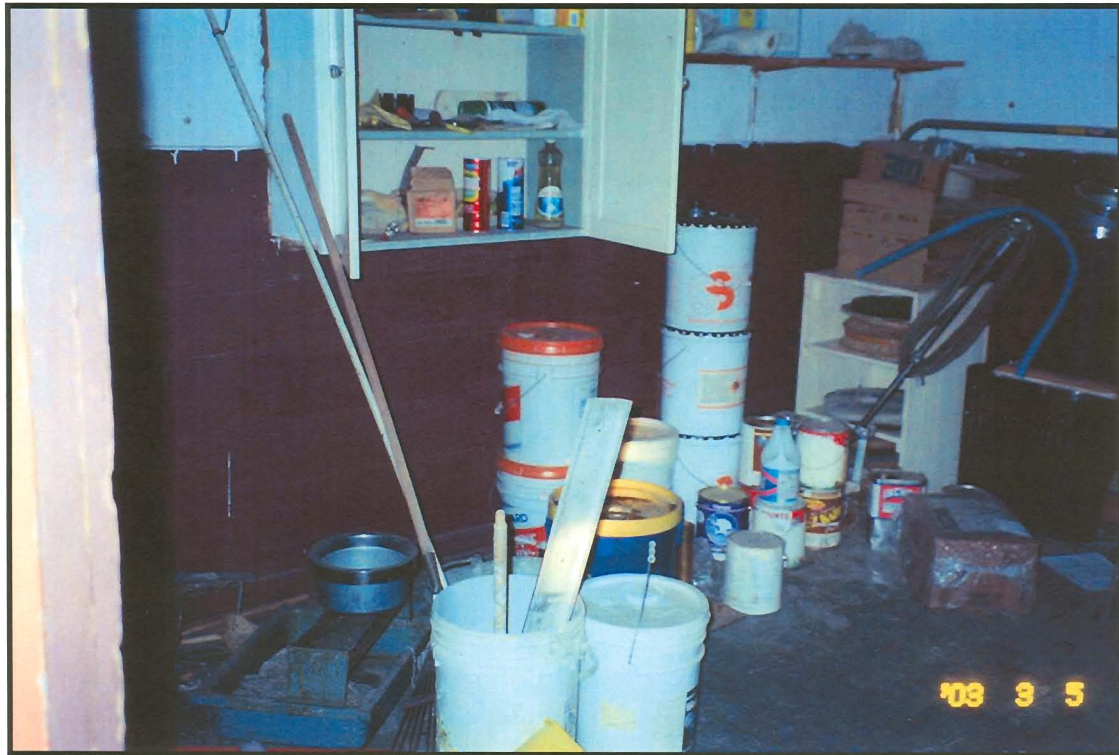
In one of the rooms located at the northeast corner of the building, there were cans of paint, containers of cleaners, and other hazardous substances not stored properly on the shelves and on the floor of the room. There was no historical evidence of the use and/or storage of petroleum products at the site and Ninyo & Moore did not observe any USTs during our site reconnaissance.

Photograph 7: View of paint containers and cleaning supplies in storage room.

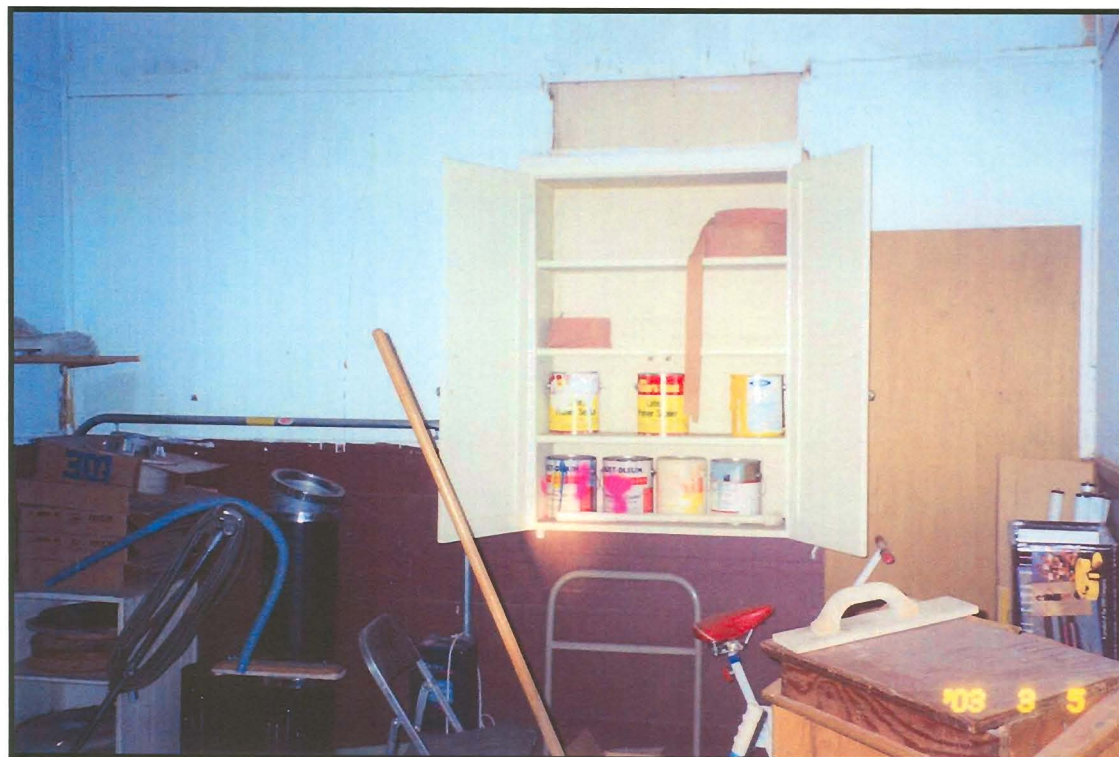
Possible hazardous materials including PCB-containing fluorescent light ballasts and freon-containing air conditioning units within the buildings at the subject site were assessed in the

Hazardous Building Materials Survey report enclosed in Appendix F. These hazardous materials will be required to be disposed in compliance with federal, state, and local regulations prior to restoration, renovation, or demolition of the structures.

Photograph 8: View of paint containers and fluorescent lights in storage room.

Ninyo & Moore did not observe possible PCB pad-mounted transformers on the subject site during our site reconnaissance. Possible PCB-containing fluorescent light ballasts within the buildings at the subject site were counted and reported in the Hazardous Building Materials Survey report enclosed in Appendix F. These materials will be required to be disposed in compliance with federal, state, and local regulations prior to restoration, renovation, or demolition of the structure.
