PHASE I ENVIRONMENTAL SITE ASSESSMENT REPORT PARCEL NO. 008-261-19 TONOPAH, NEVADA

> November 24, 2009 Project No. 302966001

Phase I Environmental Site Assessment Report

Parcel No. 008-261-19 Tonopah, Nevada

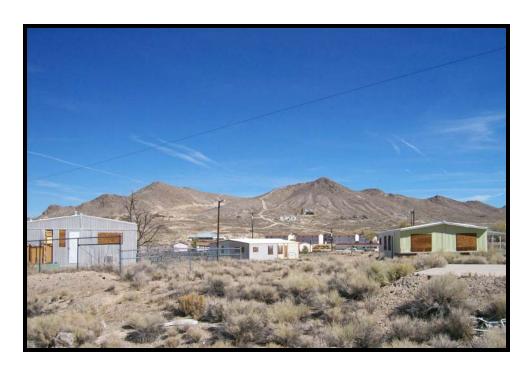
Photograph 1: View of subject site, facing northeast.

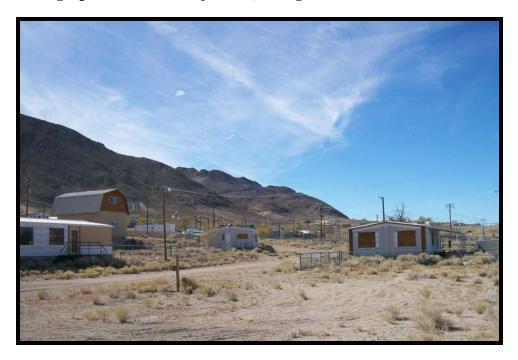
Photograph 2: View of subject site, facing northwest.

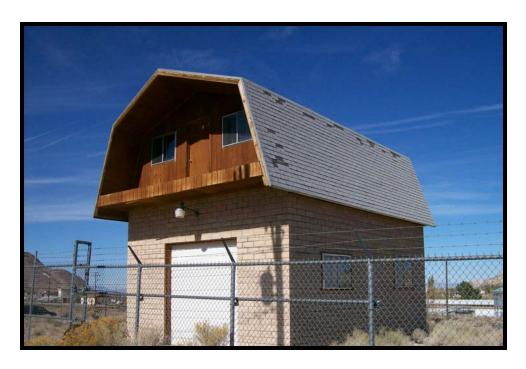
Photograph 3: View of garage and loft located near southern margin of subject site, facing northwest.

• Based on the age of the mobile homes and the garage and loft, the presence of asbestos containing material is possible. If future development plans call for renovation or demolition of the site buildings, Ninyo & Moore recommends that suspect building materials be sampled and analyzed for asbestos prior to their disturbance.

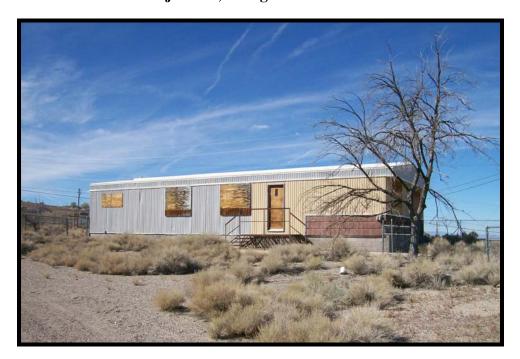
The abandoned mobile home trailers were formerly heated and cooled by pad-mounted heating and air-conditioning (HVAC) systems.

Photograph 4: View of unoccupied mobile home, facing northwest.

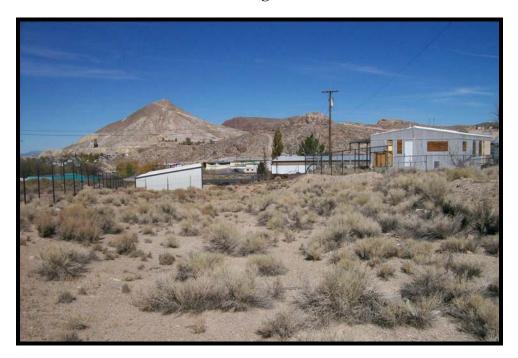
Photograph 10: View of drainage ditch on western margin of subject site, facing north.

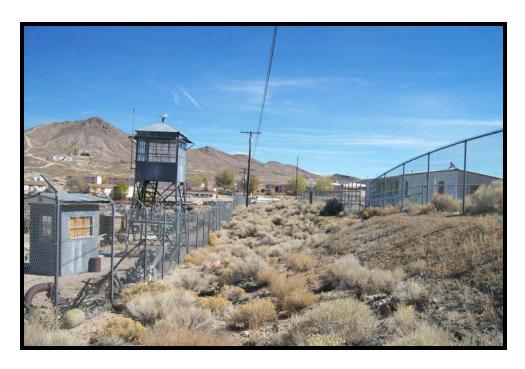
Photograph 11: View of drainage ditch on northern margin of subject site, facing east.

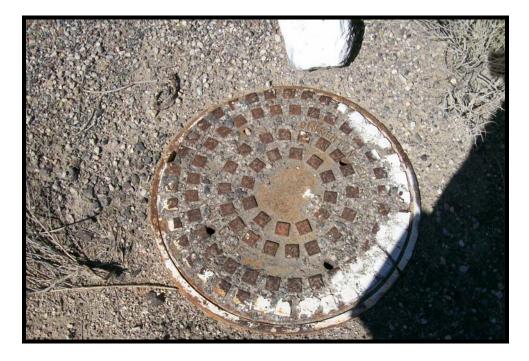
According to the Nye County Tax Assessor, there is no septic system located on the subject site. Ninyo & Moore observed several sewer manhole covers believed to be associated with the Tonopah Public Utilities sewer system.

Photograph 12: View of sewer manhole cover on subject site.

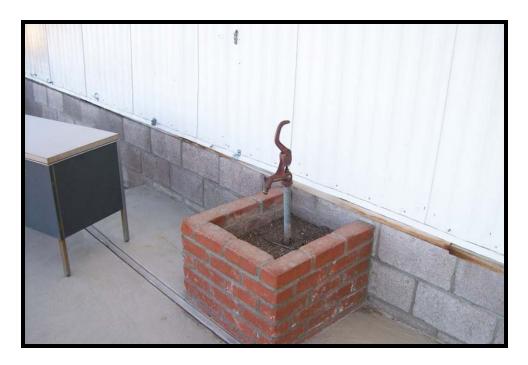
Based on the historical usage of the site and water spigots observed at each mobile home trailer, the subject site may have been connected to the municipal water distribution network.

Photograph 13: View of water spigot adjacent to site mobile home.
