# PHASE I ENVIRONMENTAL SITE ASSESSMENT

**McGill Ball Park  
56 South 4<sup>th</sup> Street  
McGill  
White Pine County  
Nevada**

***May 30, 2012  
Project No. 804.11.Task2***

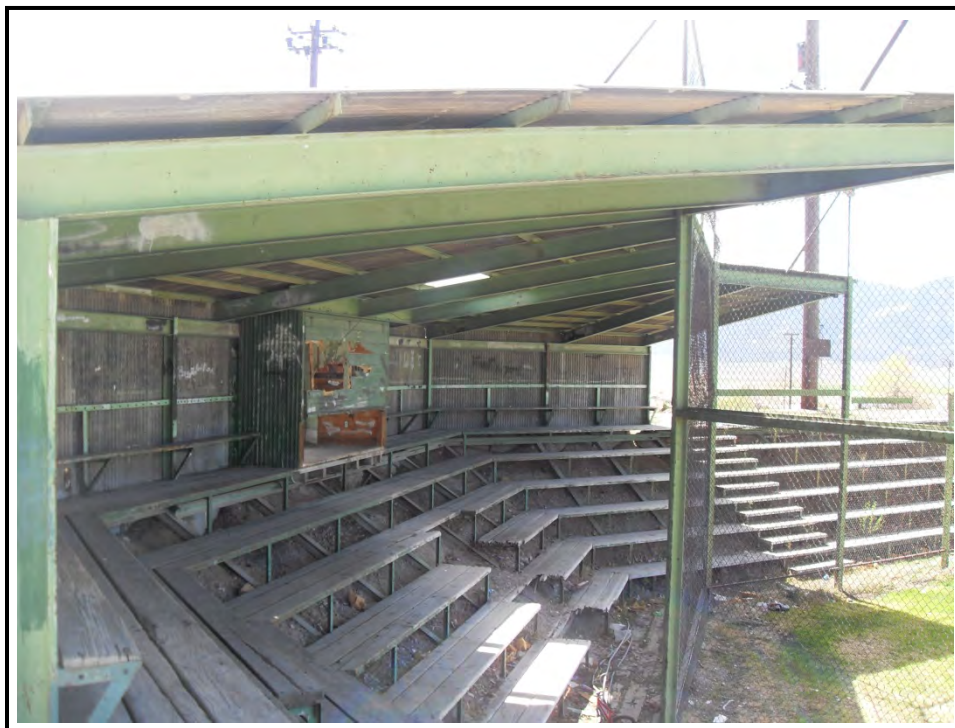
**Photograph 16:**  
View of grandstands – main ball field

- Based on the estimated age of the aerial transformers, it is likely that Polychlorinated Biphenyls (PCBs) are present within the eight transformers found at the park.
- Based on the age of the ball park grandstand structures and information revealing possible renovations occurring at the facility prior to 1978, it is likely that asbestos containing materials and lead-based paint may have been utilized during these renovations. Further, the siding of the grandstands and much of the paint were observed to be in a friable condition.

Therefore, MGA is of the opinion that due to these RECs, further environmental investigations are warranted on the subject property at this time. MGA recommends the aerial transformers, which are proposed to be replaced, be tested for PCB concentrations and disposed via local, state, and federal regulations. Further, MGA recommends that an asbestos and lead-based paint survey be performed on the building materials within structures located on the subject property that are proposed to be renovated or demolished.

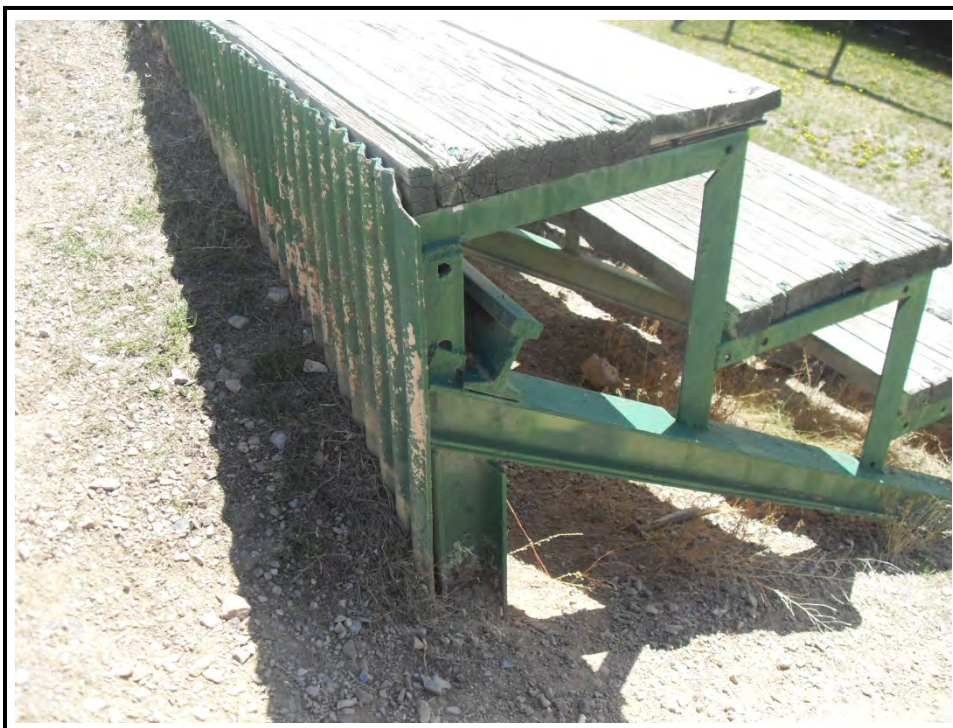
**Photograph 20:**  
**View of typical siding and green paint on bleachers**

The subject property is approximately 4.75 acres in area and is not currently utilized by the community due to the dilapidated state of the facility. A chain-link fence surrounds the property with entrance gained via a locked gate on the eastern edge of the property. The two baseball fields were observed to consist of all-grass infield and outfields. The two fields are connected to each other in the outfield portions of each field. Aerial lighting for the fields is provided via eight pole-mounted lighting systems. Each pole-system appeared to contain a transformer. The transformers appeared to be rusted and old. Grandstands are located at each field and consist of stadium-style seating consisting of wood benches. The benches appeared to have been painted green in the past but currently appear weathered and in disrepair. The metal portions of the stands are painted green and some areas were observed to be of friable condition. Portions of the grandstand walls were observed to be covered with a fiber-like siding material that appeared to be friable at the time of the site visit.

Asbestos containing material (ACM) has been identified as a potential health hazard, particularly when that material is friable and becomes damaged. Identification and sampling for the presence of ACM are beyond the Scope of Work (as outlined in Section 1.4 of this Report) for this Phase I ESA. However, given the age of the on-site structure MGA is of the opinion that asbestos containing materials are likely to be found within building materials utilized in the on-site structures. MGA recommends that a qualified inspector be contacted to provide an asbestos assessment on the on-site structures prior to future renovation.

In addition, due to the age of the structures located on the subject property, there is a potential that paint utilized for the structures may contain lead. Therefore, MGA recommends that a qualified inspector be contacted to provide a lead-based paint survey on the on-site structures prior to future renovation.

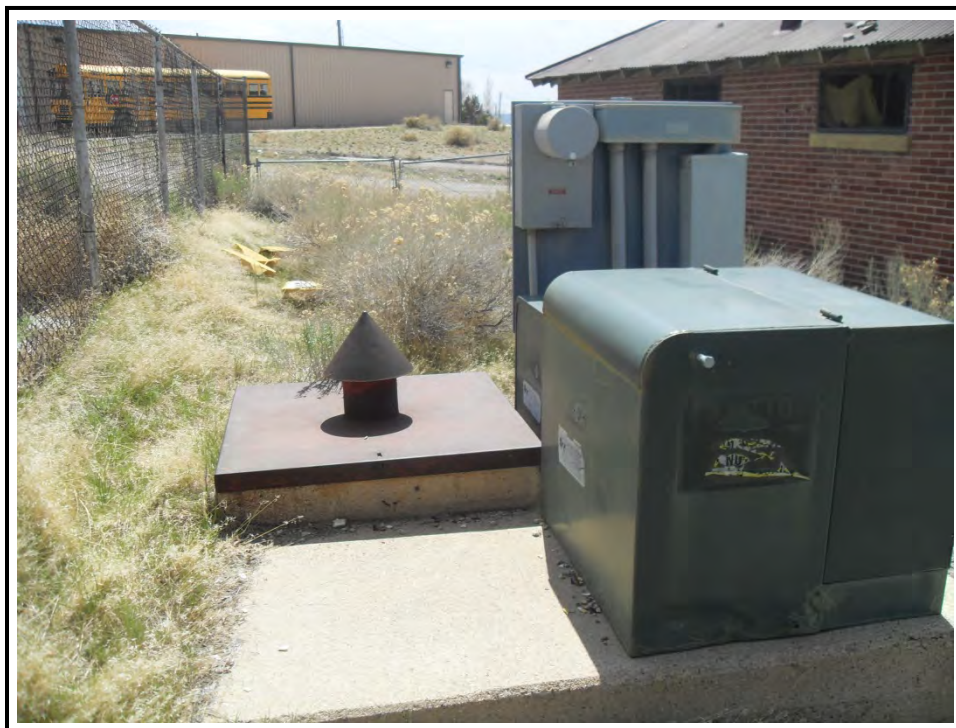
**Photograph 24:**  
View of pad-mounted transformers with utility vault venting system

*Utility vaults were observed on the property. One vault appeared to have a venting system as its cover and may have been utilized in the past to vent heat build-up within the vault.*

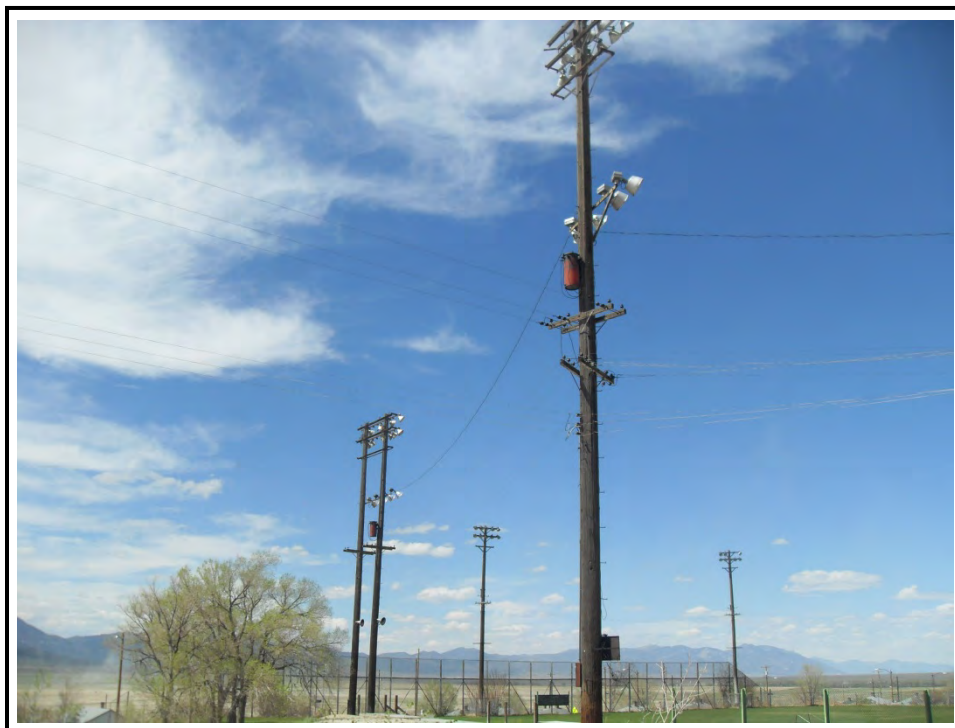
**Photograph 26:**  
**View of pole-mounted transformers**

*Eight aerial transformers were observed on the subject property. The transformers appear to be older and rusted. No stains were observed on the exterior of the transformer or on the pole structure.*

Eight aerial transformers were observed on eight pole-mounted lighting systems utilized by the baseball fields. The transformers appeared to be rusted but without staining. Historic information for the subject property appears to indicate that the aerial transformers are privately owned and not serviced by the local power company. In addition, it appears that the transformers were installed prior to 1961, and therefore, a possibility exists that the fluid within the transformers contain PCBs.

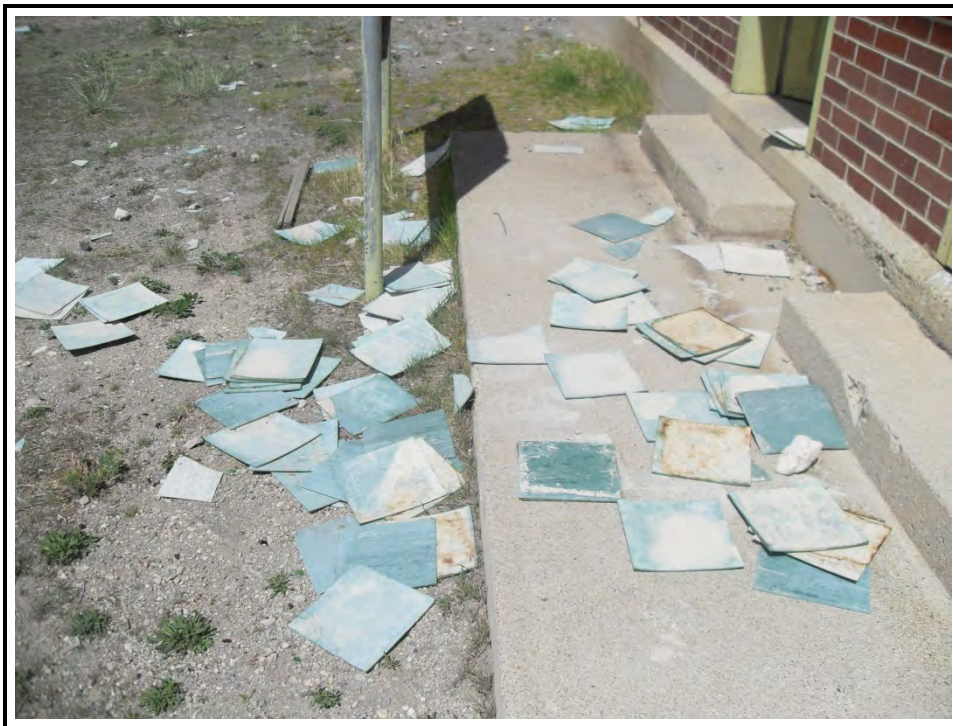
**Photograph 29:**  
**View of scattered bathroom tiles proximal to bathroom structure**

The children's play area located adjacent and to the west of the baseball fields appeared to be in a state of disrepair. The bathroom structure, located on the eastern edge of the play area, also appeared to be in a state of disrepair. Multiple floor tiles and other debris were noted proximal to the bathroom doorway and the interior of the bathroom was observed to be in a dilapidated state. Utilities observed in this area consisted of two pad-mounted transformers with labels indicating they were PCB free. In addition, what appeared to be a utility vault with a vent pipe was observed proximal to the transformers.

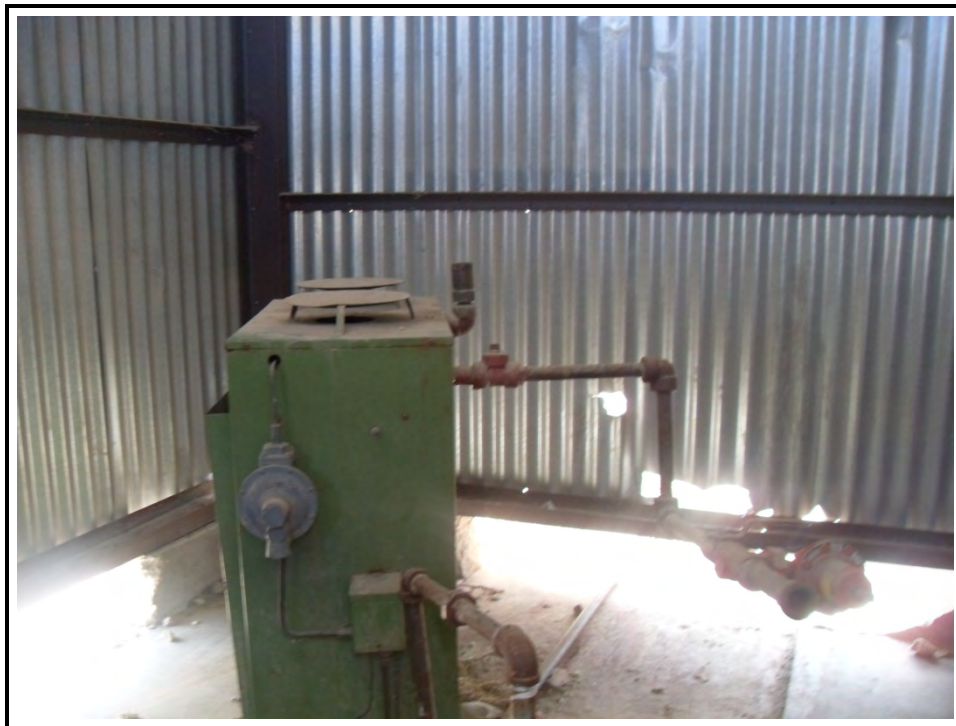
**Photograph 31:**  
**Propane heater equipment in shed adjacent to bathroom (outside of fenced area)**

*It appears that a possible steam heating system was utilized at the site in the past. Currently, what appeared to be a propane heating unit was observed within a shed proximal to the bathroom structure on the northeastern portion of the subject property.*
