**PHASE I
ENVIRONMENTAL SITE ASSESSMENT REPORT
1961 SOUTH BARADONNA ROAD
PARCEL NUMBER 036-351-25
PAHRUMP, NEVADA**

February 16, 2009
Project No. 302830001

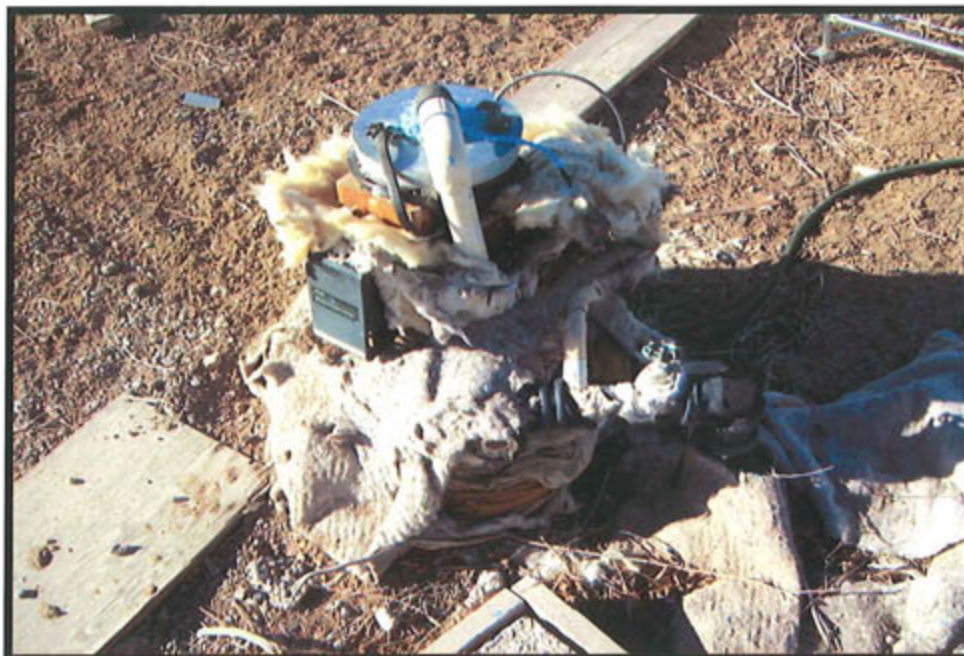
- The Nye County Tax Assessor information indicates that there is a domestic well located on the subject site. During the site visit, the domestic well with associated pump was observed to the west of the small structure located on the subject site. The well may constitute a direct pathway to groundwater.

Photograph 12: View of domestic well with associated pump located on the subject site.

- The domestic well located on the subject site west of the small structure may constitute a direct pathway to groundwater. Ninyo & Moore recommends that the well be abandoned by a Nevada-certified driller in accordance with applicable local and state regulations.

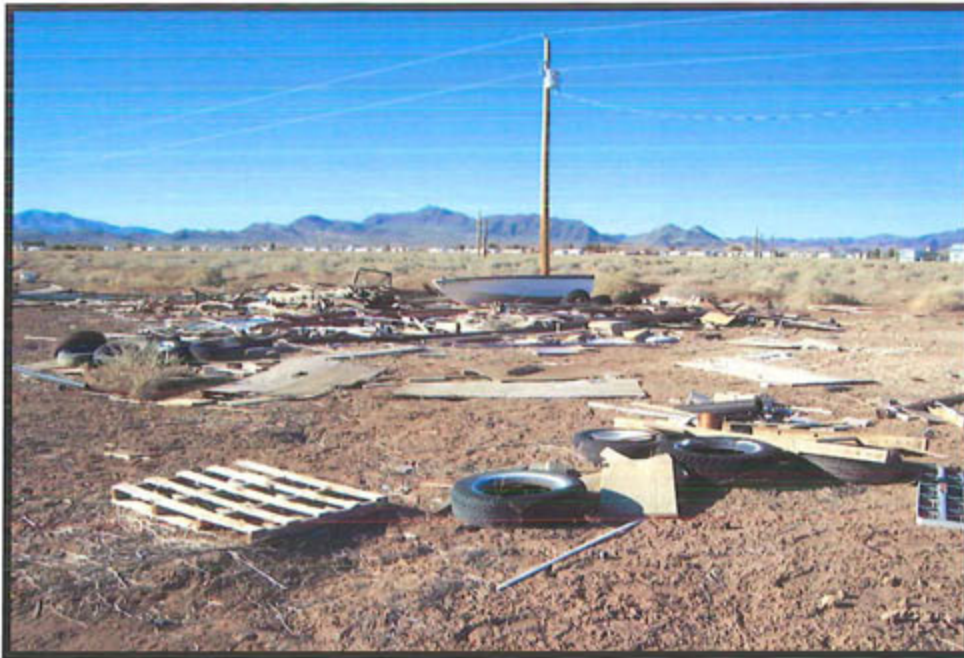
- No abnormal solid waste, including fill, was observed on the subject site. However, an abandoned boat, general debris, and waste consisting of miscellaneous building materials were noted near the northeast corner and northern margin of the subject site. The general debris and miscellaneous building materials consisted of polyvinyl chloride pipe (PVC) pipes, tires, concrete, buckets, wood, various metal sections, a satellite dish, and building insulation.

Photograph 13: View of general debris, building materials, and abandoned boat, facing northwest.

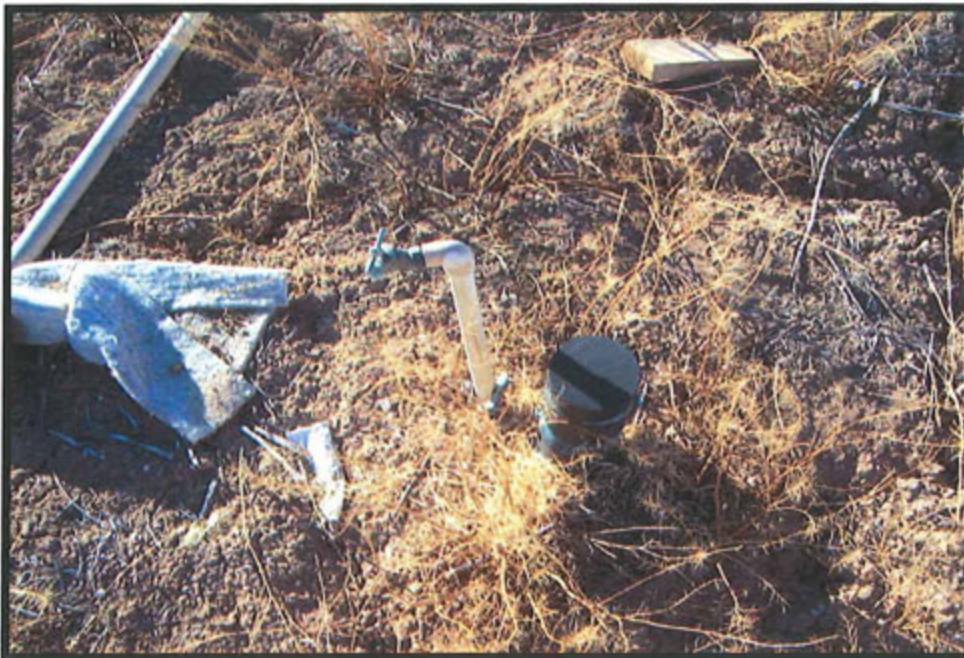
- The Nye County Tax Assessor information indicates that there is a septic system located on the subject site and a PVC pipe, believed to be associated with the septic system, was observed on the subject site, east of the mobile home trailer. Based upon our reconnaissance of the subject site, it is not currently served by a municipal wastewater treatment system.

According to the Nye County Tax Assessor, a septic system is located on the subject site. A possible cleanout access point associated with the septic system was noted east of the mobile home trailer.

Photograph 14: View of septic system PVC pipe located on the subject site.

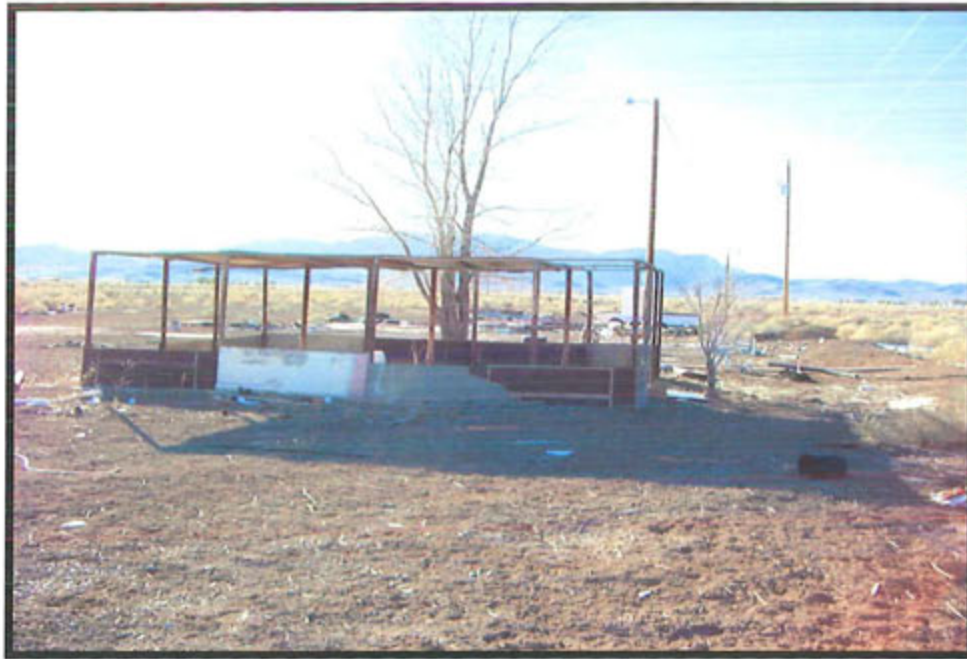
Photograph 15: View of small structure located on the subject site, facing west.

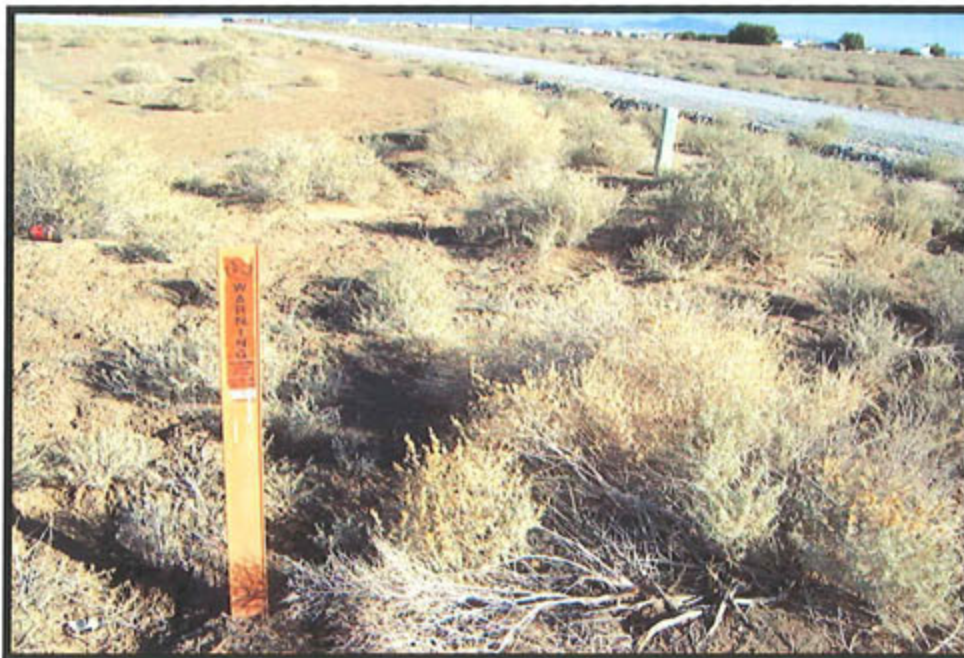
Photograph 16: View of utility warning marker and utility box located near southwest corner of subject site, facing southeast.

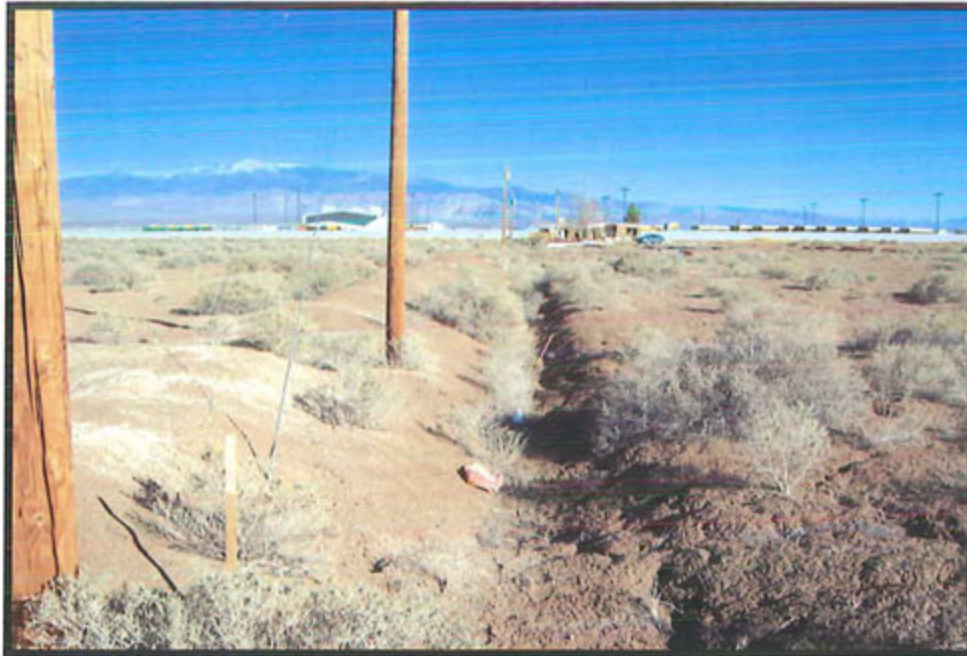
Photograph 17: View of utility trench located near northern margin of the subject site, facing east.

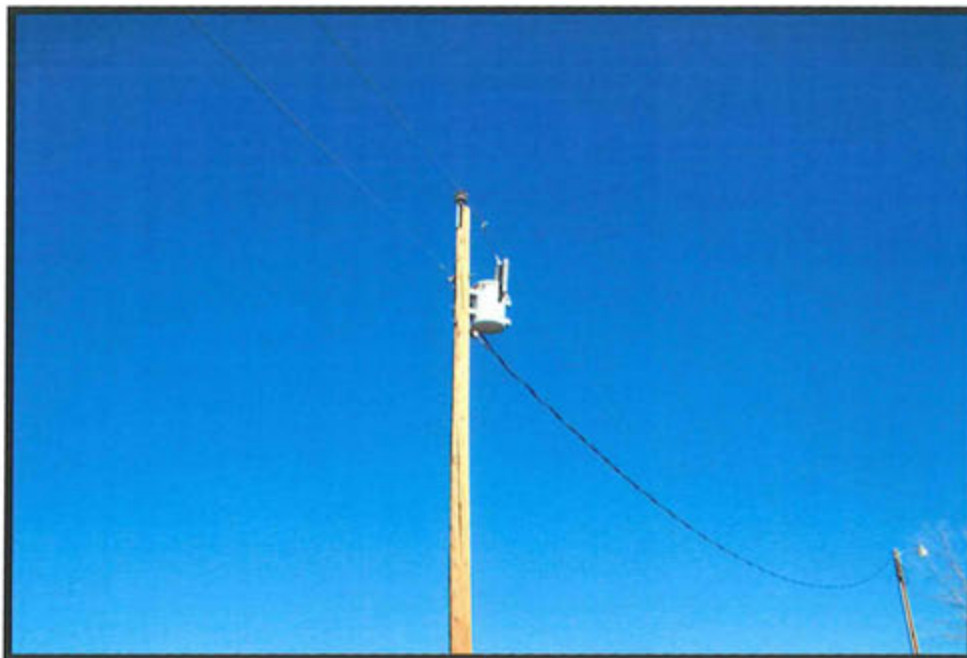
Photograph 18: View of pole-mounted transformer, facing northeast.

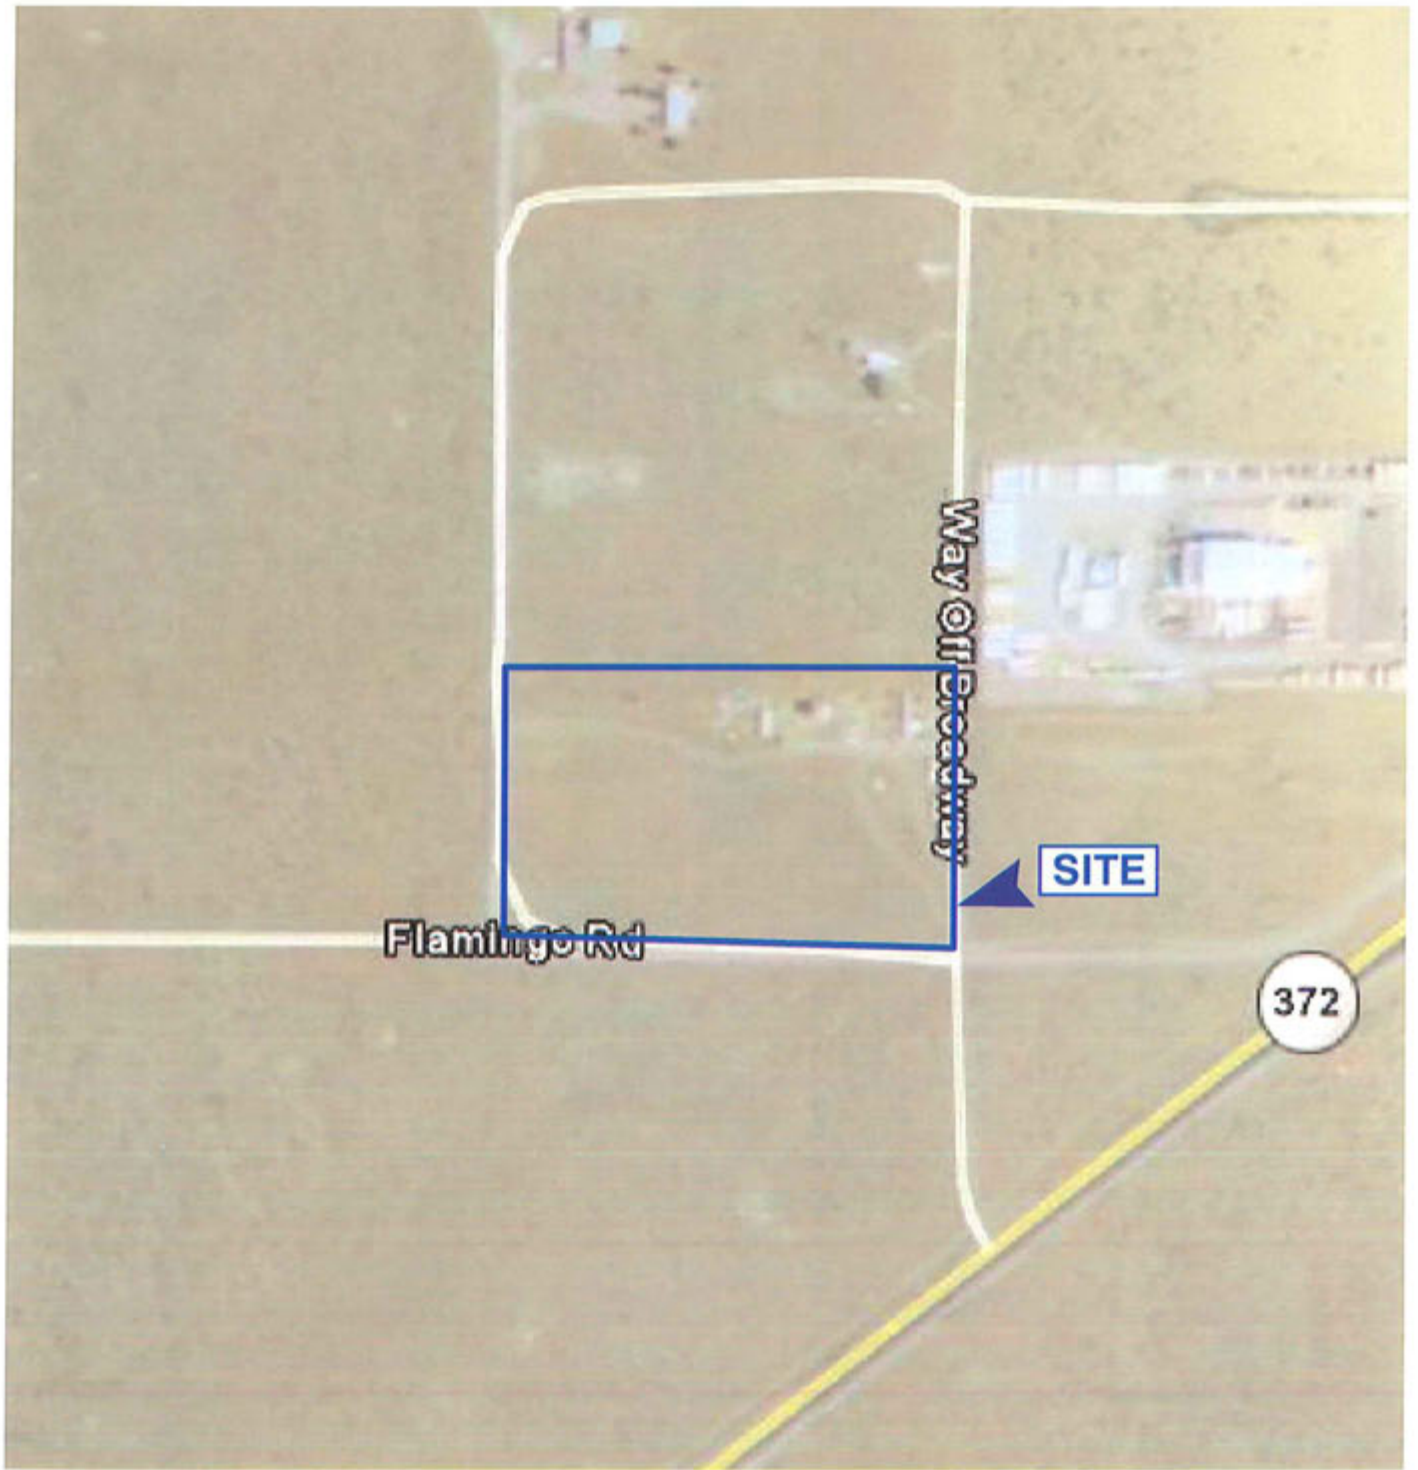
Selected historical aerial photographs from 1984, 1994, and 2008 were available and reviewed for the subject site. Aerial photographs prior to 1984 were not readily available. The lack of availability of aerial photographs prior to 1984 is not considered a significant data failure due to the undeveloped state of the subject site during that period. A listing of the photographs reviewed is presented in Table 2. Table 3 summarizes notable observations from each photograph. A copy of the 2008 aerial photograph is included in Appendix D-2.

SOURCE: GOOGLE EARTH, 2008.
